**MEMORANDUM**

**RE: VOORHIES HALL NEEDS ASSESSMENT & CONCEPTUAL DESIGN STUDY  
BAY VIEW ASSOCIATION  
PETOSKEY, MI  
QE #: 52600980**

Subject: **Building Description and Existing Conditions Assessment Summary**

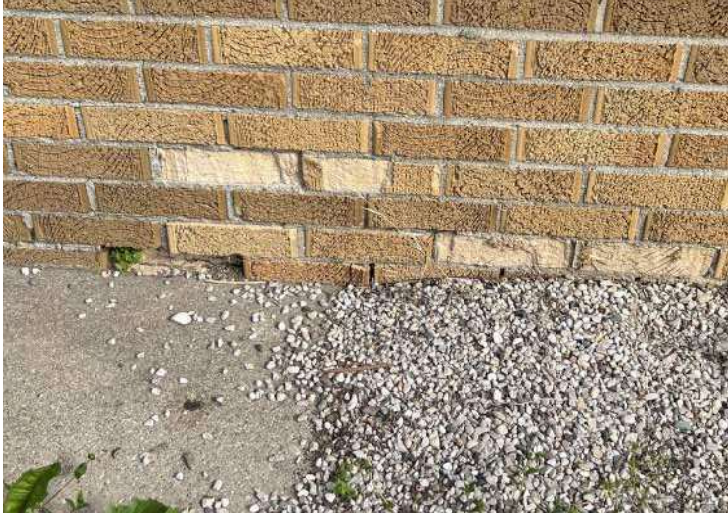
- Bricks are in excellent condition except for some face spalling on the west and south sides.

Minor brick deterioration at wall base, south elevation

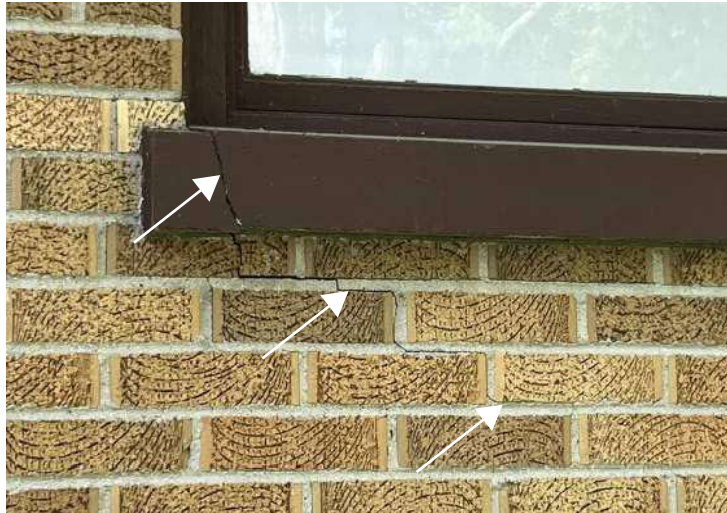
- The exterior wall assembly, made up of concrete masonry units and brick veneer, are assumed to be uninsulated.
- The fixed metal windows with single pane glazing are generally in good condition. However, there is notable cracking and spalling where the window sills meet the brick façade, likely due to the freeze thaw cycle. A large window at the north side of the stage is blacked out, since having a window onstage is undesirable.
- The pitched asphalt shingle roof and flat rubberized membrane roofs were replaced in 2008. There is leaking occurring, causing ceiling damage at the southwest stair. The cause of the leak is unknown.

Cracked sill and step cracking of brick - typical at **all** windows

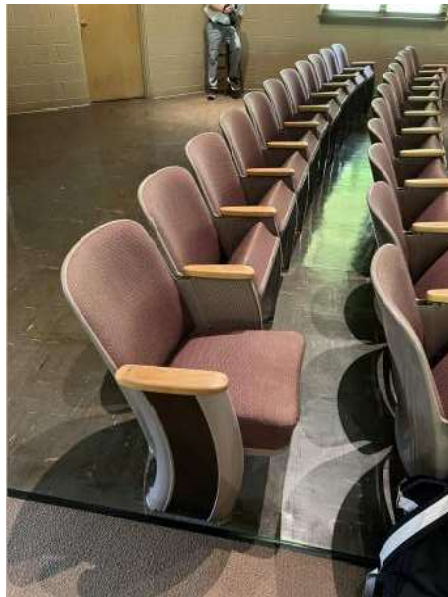
- Finishes are generally in fair condition but are dated. There have been multiple complaints regarding a strange odor when entering the building.
- Seating is fully fixed, with a center and side aisles. The seats appear original to the building, however previous documentation notes that the seats have been reupholstered at least once. Several of the spring mechanisms are worn out and many of the seats do not automatically flip up.

Many seats no longer flip up

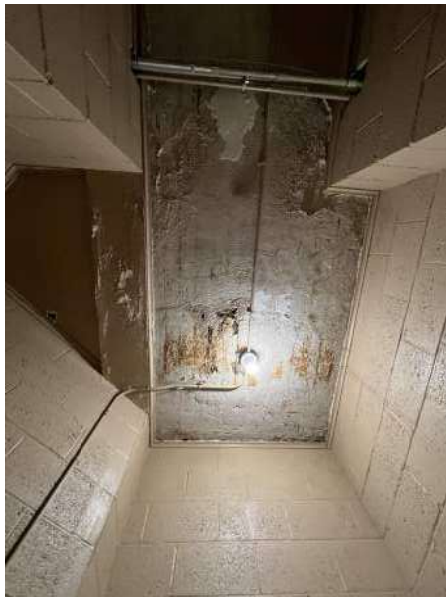
Water damage at backstage ceiling

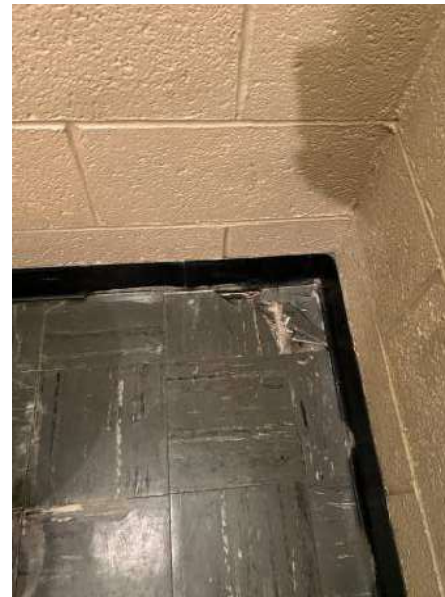
- The flooring likely consists of 10x10 asbestos vinyl tile (a common mid-century material) that is deteriorating at the backstage restroom and the northwest auditorium exit door threshold. Also, it should be assumed that the 1953 building has lead-containing paint. It is recommend Bay View perform hazardous material testing.

Flooring damage at backstage restroom

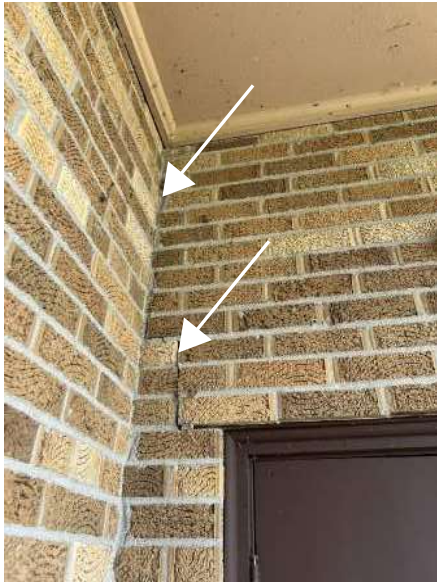
- There are no signs of settlement in the exterior walls other than potentially one location where there is a large vertical crack in the masonry wall and brick veneer at the northwest exterior door.
- There is notable step cracking and popping under many of the exterior window sills.
- The 4x4 post at the mechanical equipment canopy on the west (back) side of the building is warped and twisted.
- There is some brick delamination and popping due to water infiltration and freeze-thaw cycling.
- Overall, Voorhies Hall seems well-built, structurally.

Exterior cracking at NW door

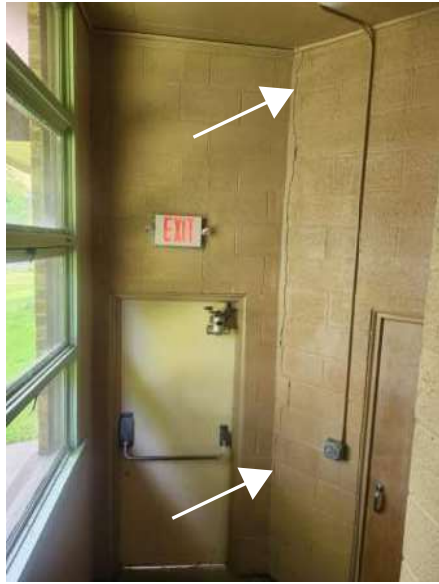
Interior cracking at NW door

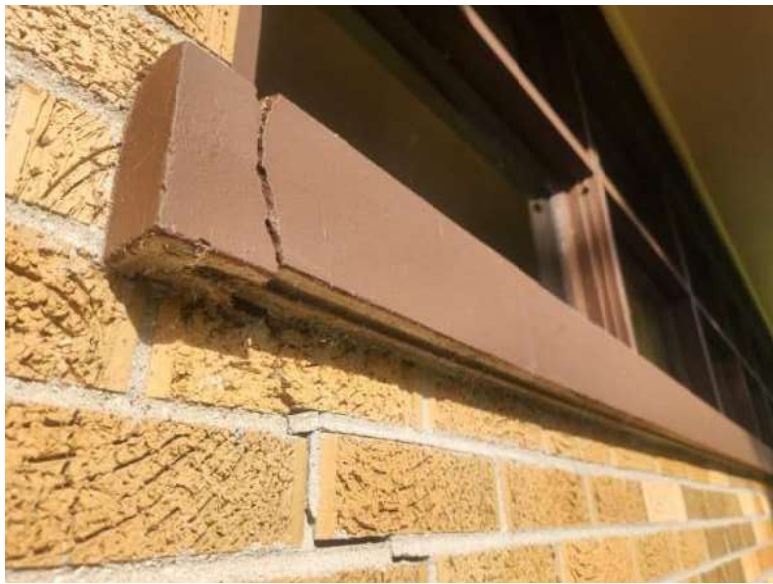
Detail of cracking sill condition

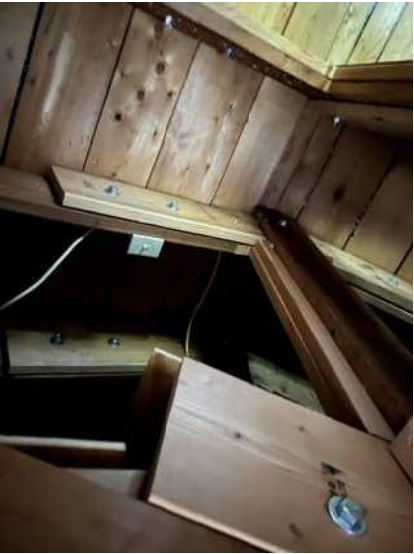
2012 roof repairs

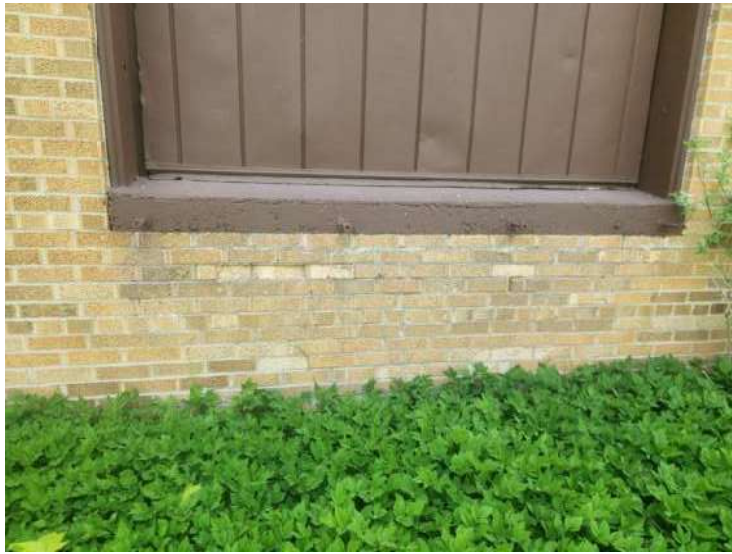
Stage door sill and brick deterioration

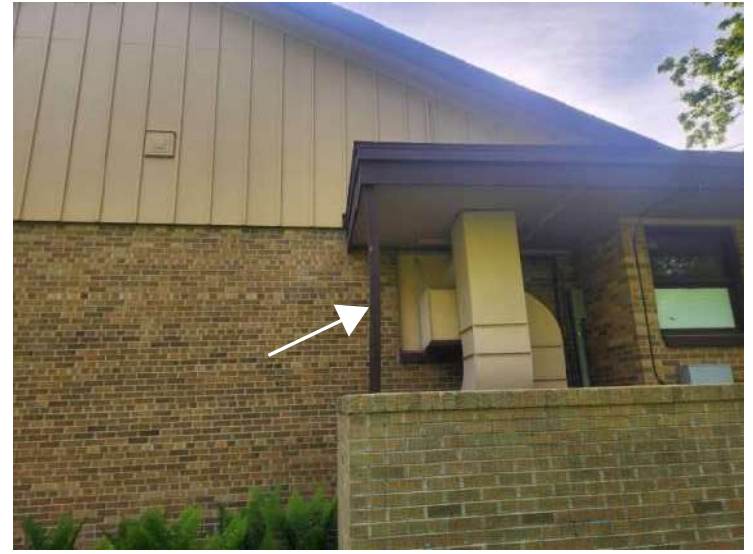
Warped 4x4 post at rear mechanical area

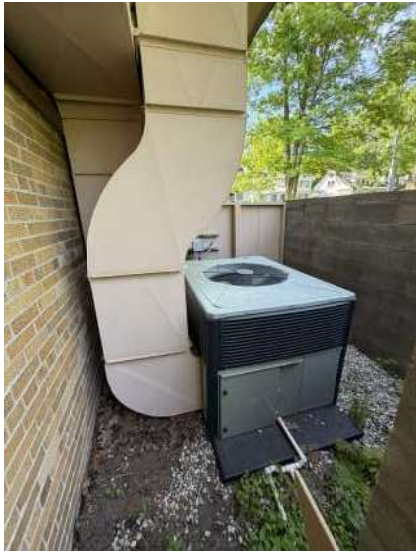
- Mechanically, there are no exhaust fans installed in any restroom.
- There is a single 5-ton rooftop unit, installed on grade, that serves heating, ventilation, and A/C to the Stage and Auditorium.
- There is a single duct supply run to the Ticket Booth.
- The Lobby, Lounge and Toilet rooms do not have any HVAC installed.
- The building has natural gas - with the rooftop unit being the only connected appliance.
- The rooftop unit was installed in 2008. This unit should be replaced.

Exterior mechanical equipment

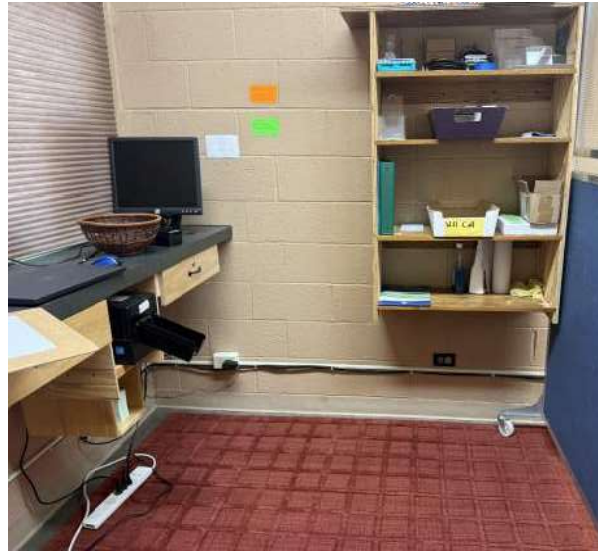
Widely used extension cords and plug strips within the ticket office

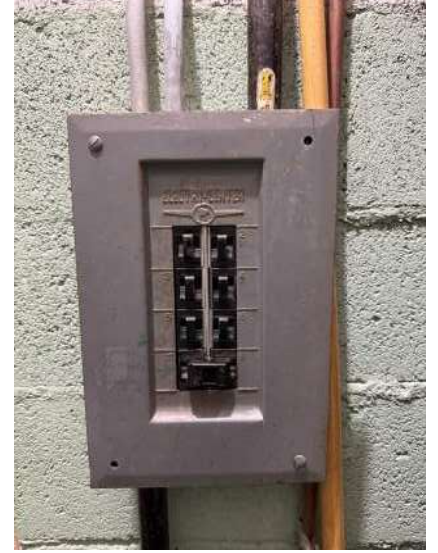
Old electrical panel

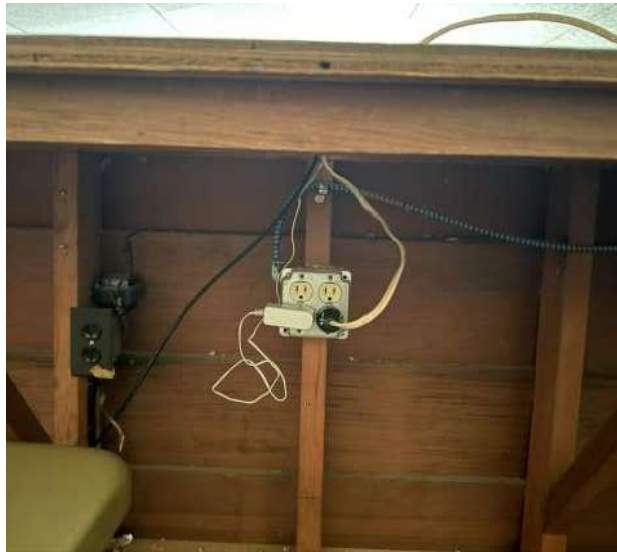
Widely used extension cords and plug strips within the spotlight booth

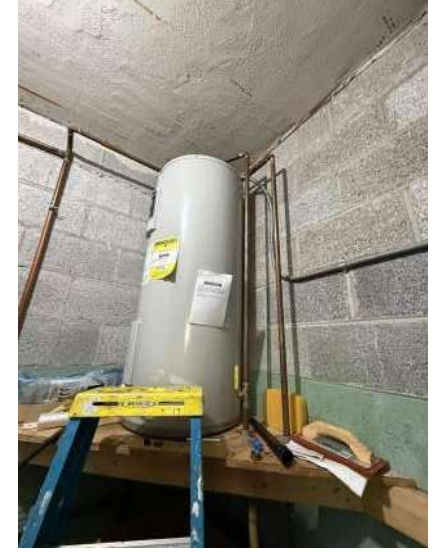
- Other fixtures within Voorhies Hall include a service sink and a drop-in sink.
- There is an existing electric water heater, 40-gallon, 4500 W that serves the gang toilet rooms. It was installed in 2012 but appears in good working condition. It is probably nearing the end of its life, but with seasonal use and good maintenance, there is a chance it could last a few more seasons.

40-gallon water heater

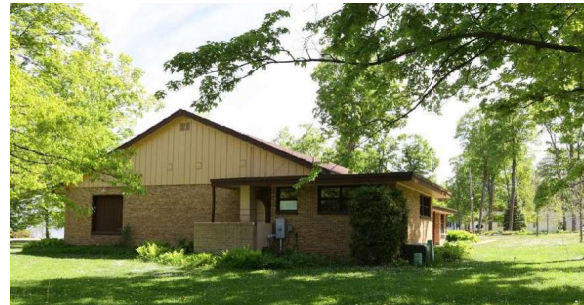
**Rear Elevation**  
Landscape does not screen views of utility infrastructure.

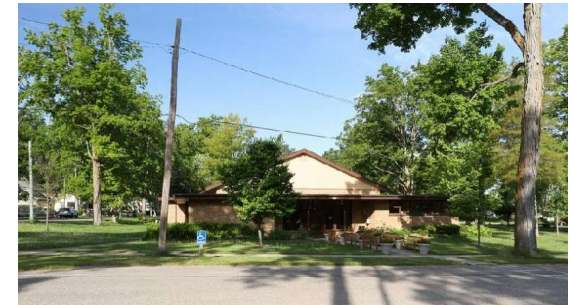
**Overhead Utilities**  
View of front elevation is compromised by overhead utility lines. Site lighting is provided by unshielded street lights attached to existing utility poles.

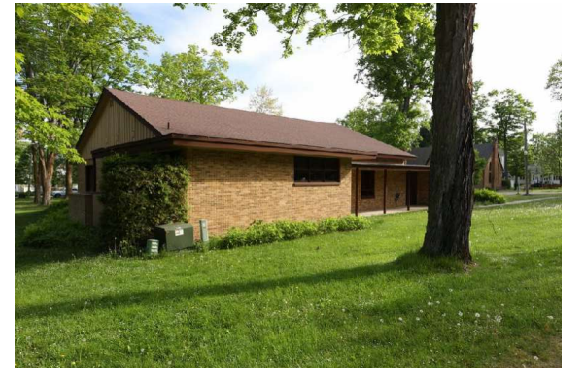
South Elevation

Utility infrastructure is partly screened with Arborvitae. A closer look at topography indicates a slope from the roadway to the exit and ticket booth, which can occasionally flood the building edge.
