**MEMORANDUM**

**RE: VOORHIES HALL NEEDS ASSESSMENT & CONCEPTUAL DESIGN STUDY  
BAY VIEW ASSOCIATION  
PETOSKEY, MI  
QE #: 52600980**

Subject: **Building Description and Existing Conditions Assessment Summary**

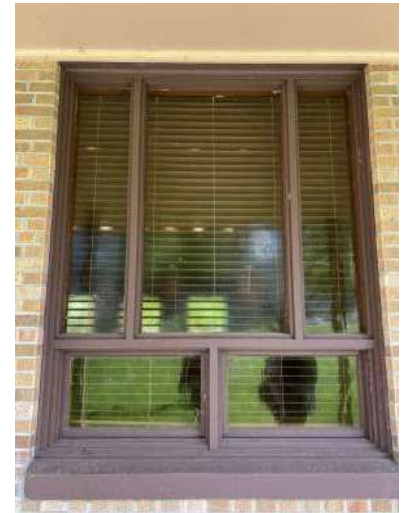
Auditorium window

- The exterior wall assembly, made up of concrete masonry units and brick veneer, are assumed to be uninsulated.
- The fixed metal windows with single pane glazing are generally in good condition. However, there is notable cracking and spalling where the window sills meet the brick façade, likely due to the freeze thaw cycle. A large window at the north side of the stage is blacked out, since having a window onstage is undesirable.
- The pitched asphalt shingle roof and flat rubberized membrane roofs were replaced in 2008. There is leaking occurring, causing ceiling damage at the southwest stair. The cause of the leak is unknown.

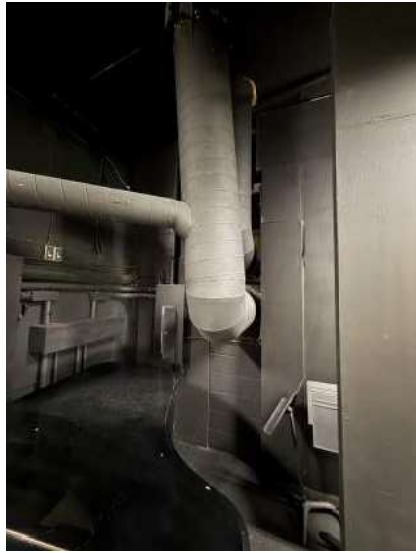
Backstage ducting

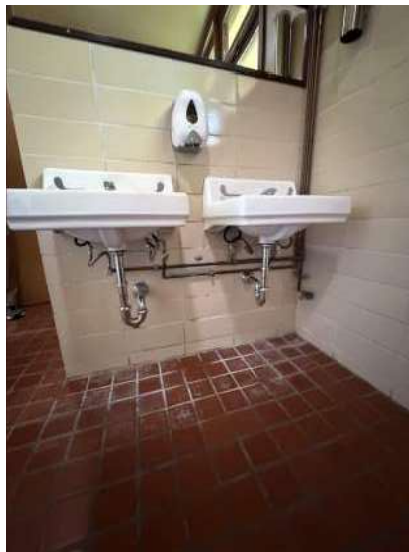
Wall mounted restroom sinks

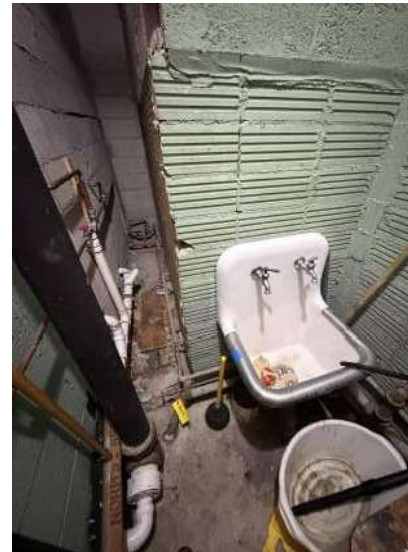
- Other fixtures within Voorhies Hall include a service sink and a drop-in sink.
- There is an existing electric water heater, 40-gallon, 4500 W that serves the gang toilet rooms. It was installed in 2012 but appears in good working condition. It is probably nearing the end of its life, but with seasonal use and good maintenance, there is a chance it could last a few more seasons.

Service sink

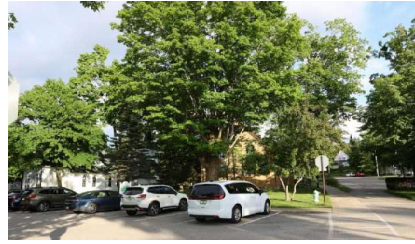
**Parking**  
Parking at Library is often used for Voorhies Hall events.

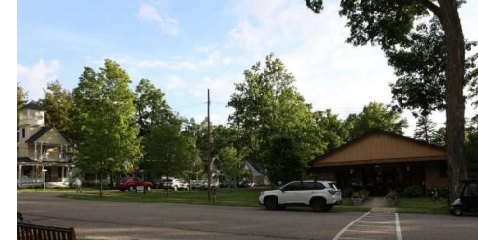
**Accessible Parking**  
Accessible Parking on Encampment Ave. is in close proximity to main entrance, but driver door opens toward the street.

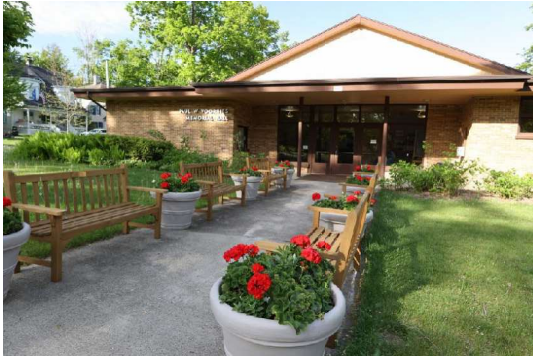
Main Entrance

Landscape plants include Lilac trees flanking the building entrance and planters along either side of the entrance walk, adding spring color and strengthening the symmetry of the building elevation. Topography is virtually flat, providing a number of accessible routes before Encampment Ave. rises to the south.

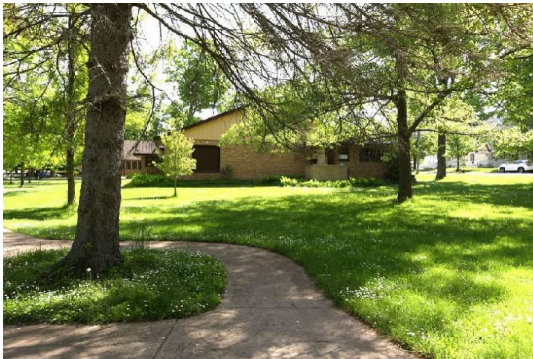
Rear Elevation

The site landscape is completed by native ferns at the building foundation, and a mature tree canopy providing shade and cooling. The mature tree canopy extends over the rear building elevation; however, there is one large declining spruce tree in the center of the pedestrian walkway, and landscaping allows views to utility infrastructure. Topography slopes away from the north elevation and covered exit, providing positive drainage.
